River City Home Inspections

Property Inspection Report

1000 Main St , Grand Rapids, Mi 49506
Inspection prepared for: Bill Smith & Donna Smith
Date of Inspection: 5/14/2015 Time: 2pm
Age of Home: 32 years old (1983) Size: 1700 Sq ft
Weather: 52 degrees, cloudy
Updated Version

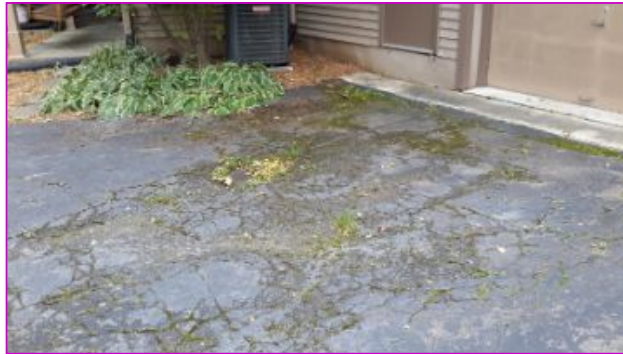
2. Driveway Condition

area at bottom of hill with some settling

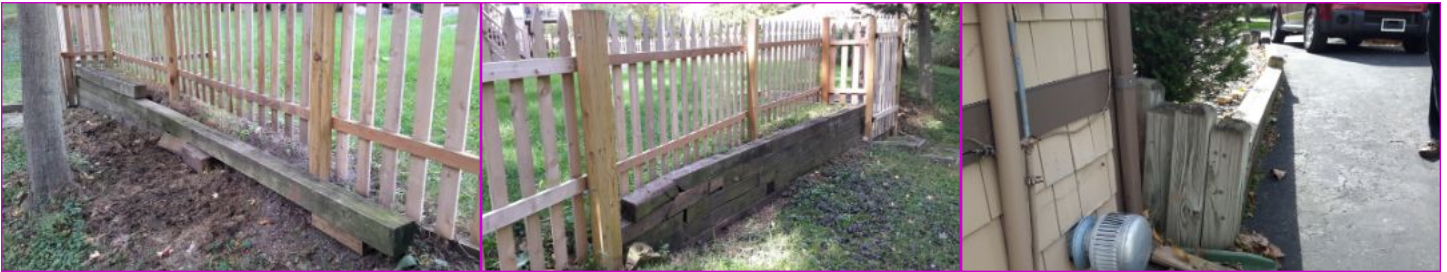
7. Retaining Wall Condition

will need some work

needs some stabilization

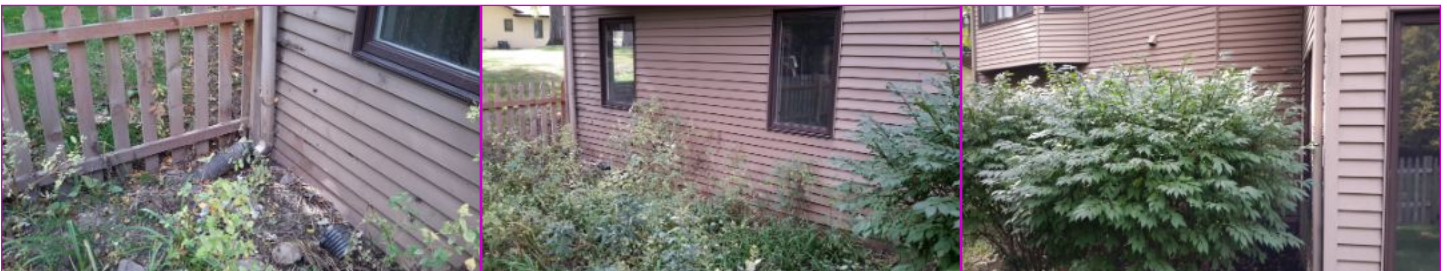
- Some vegetation around the exterior walls was overgrown and needed to be cut back.

try to keep 6 inches below siding at house

be aware of clearance at base of wall

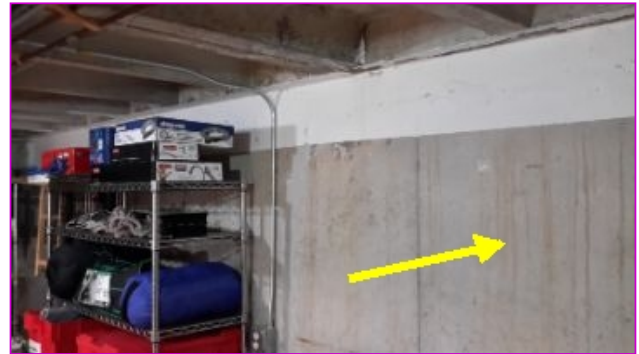
*lower with minor water staining*

- Only moisture intrusion seen was in lower garage, possibly a one time event caused by driving rain at the front of the home.

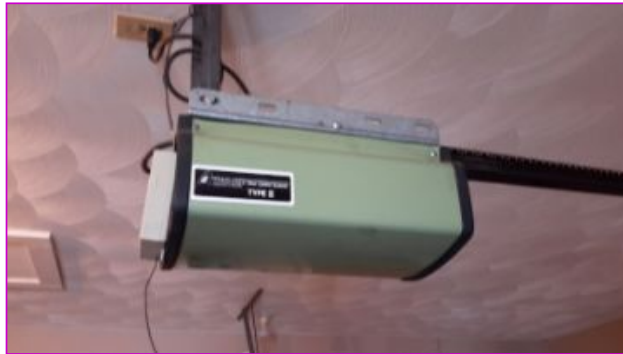
1. General Condition

- At the time of the inspection, the Inspector observed few deficiencies in the condition of the overhead vehicle doors. Notable exceptions will be listed in this report. Both openers have auto reverse if they make contact with something. Neither have electronic eyes however, to auto reverse if someone is standing or walking underneath the door. Recommend installing eyes on both units.

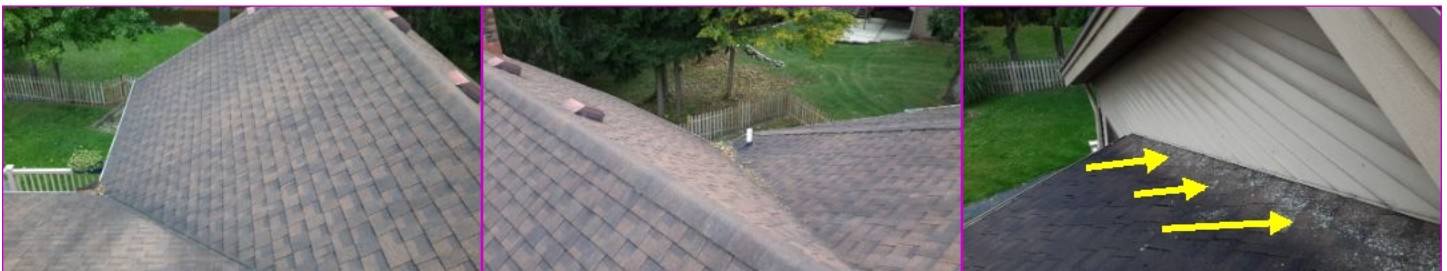
areas of lichen growth

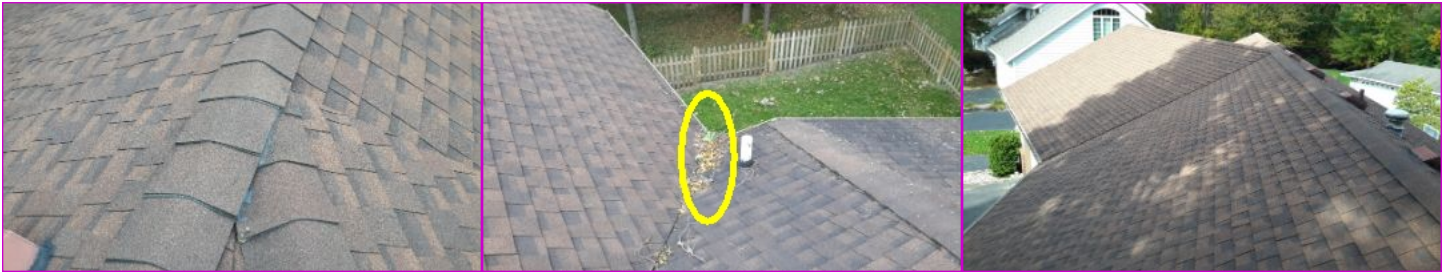
be aware of valleys filling with sticks and leaves

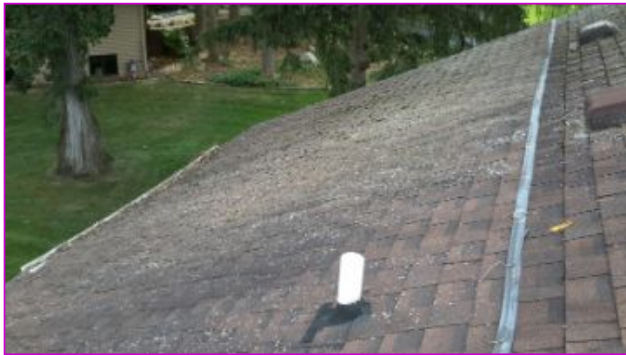
area on rear of home with lichens and algae growth

Algae discoloration is difficult to remove from roofing surfaces, but may be lightened by applying a solution of chlorine bleach, trisodium phosphate, and water. Solutions for these ingredients may vary between shingle manufacturers and it's best not to make direct recommendations but to recommend a qualified contractor.

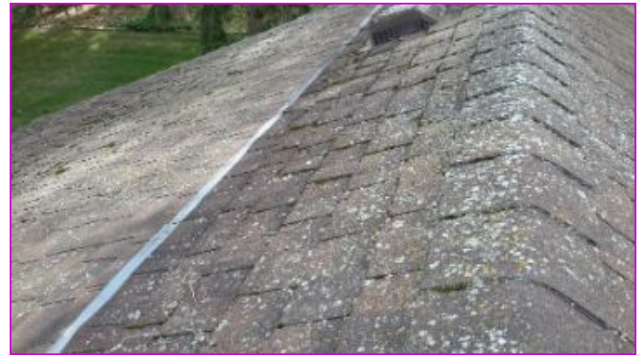
area on rear of home with algae and lichen growth

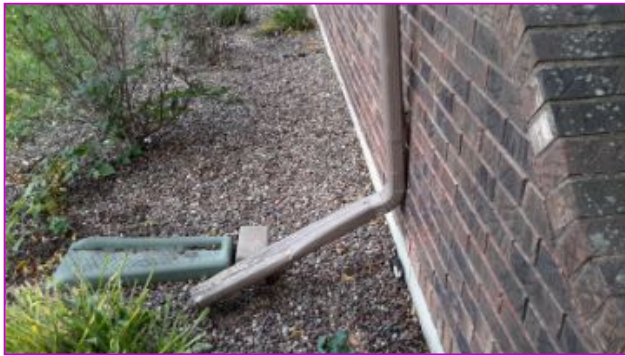
- One or more downspouts discharged roof drainage next to the foundation. This condition can effect the ability of the soil to support the weight of the structure above and can cause damage related to soil/foundation movement. The Inspector recommends the installation of downspout extensions to discharge roof drainage a minimum of 6 feet from the foundation.

ideally drains 6 feet from foundation

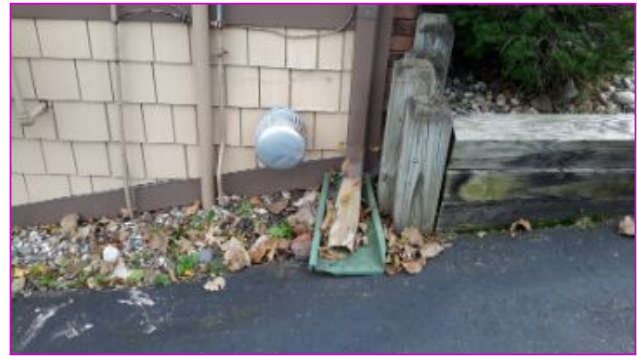
keep clear, and extend if possible

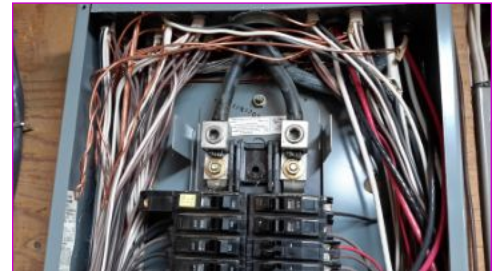
1. General Condition

- At the time of the inspection, the Inspector observed few deficiencies in the condition of the electrical system. Notable exceptions will be listed in this report. 4 circuits were removed from the main box, and a sub panel was added to accommodate those 4 circuits. The removal could have been done more professional, but is functional. Also, main breaker is in garage for homes 200 amp service.

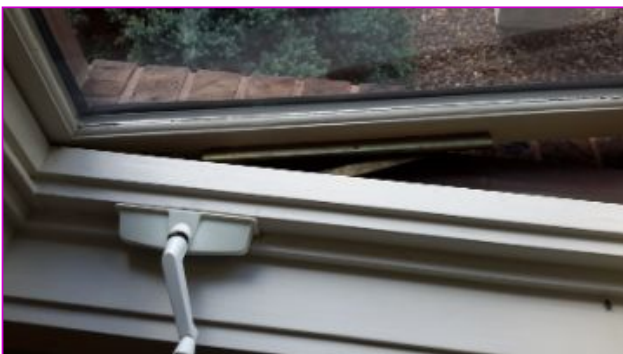
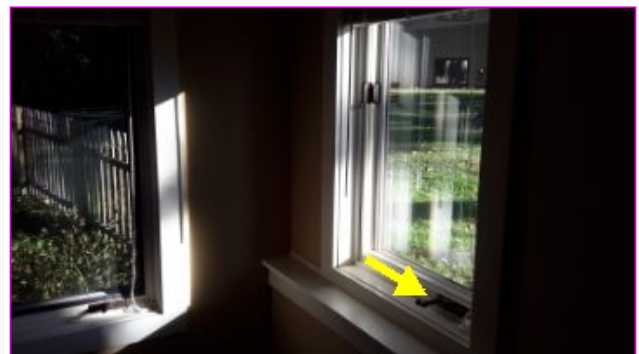
• Windows in the home exhibited moderate deterioration. The opening mechanism is stripped on at least 4 windows in the home. 3 on the main floor, two of them being the bedroom and the other in the front half bath. Downstairs, the far bedroom on the left has the same issue with the single window on the far wall. The window in the main floor bedroom is an egress window and must be functioning.

basement bedroom example of stripped crank

• As stated in another part of report, monitor and check that all window cranks are operating successfully.

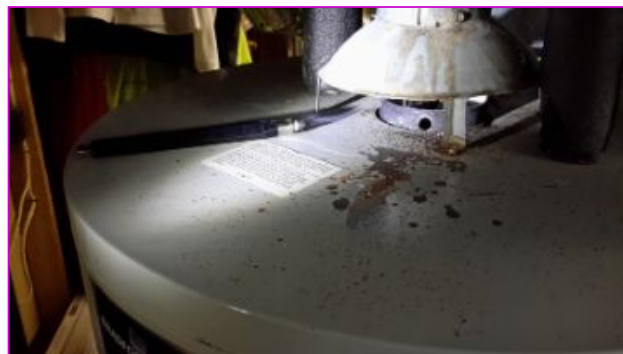
4. Combustion Exhaust

proper draft

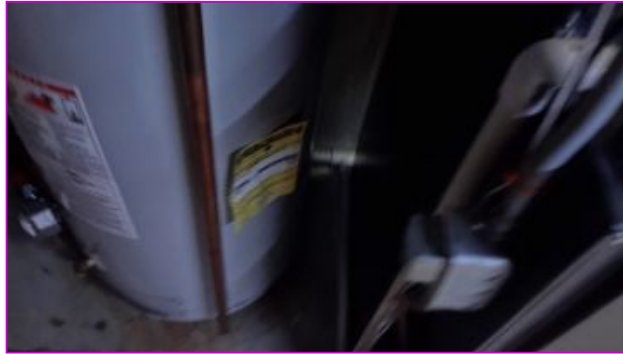
6. TPR Discharge Pipe

proper discharge location

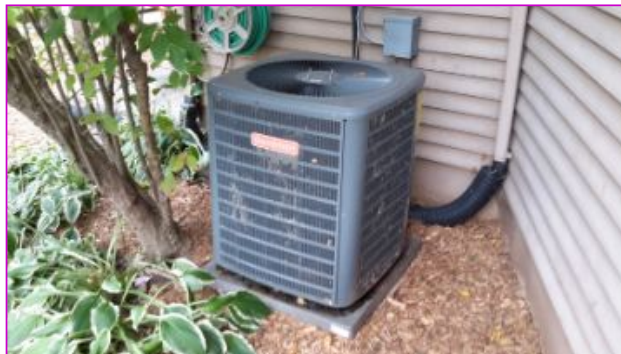
1. General Condition

- At the time of the inspection, the Inspector observed few deficiencies in the condition of the air-conditioning system. Notable exceptions will be mentioned in this report. Due to outside air temperatures below 65 degrees I did not test the AC today. Testing at these temperatures can harm the units. The exterior part of the system, the compressor, appears to need thorough cleaning. Recommend a tune up by professionals before firing it up next summer.
