River City Home Inspections

Property Inspection Report

1000 Main St , Grand Rapids, Mi 49506
Inspection prepared for: Bill Smith & Donna Smith
Date of Inspection: 5/14/2015 Time: 2pm
Age of Home: 32 years old (1983) Size: 1700 Sq ft
Weather: 52 degrees, cloudy
Updated Version

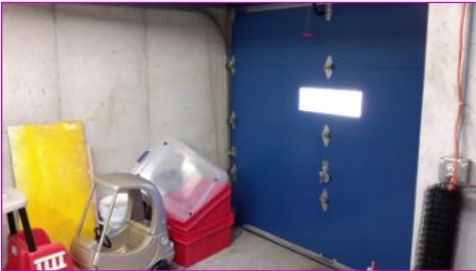
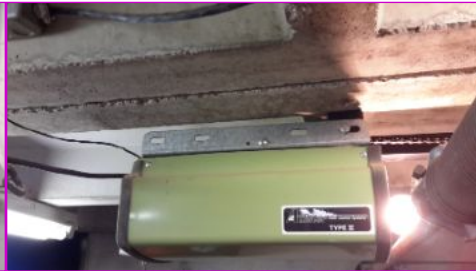
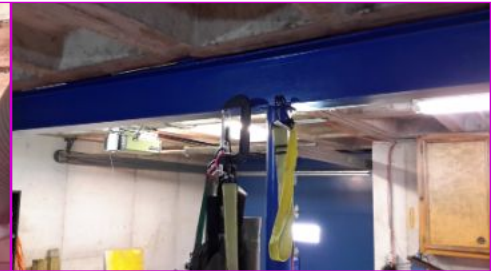
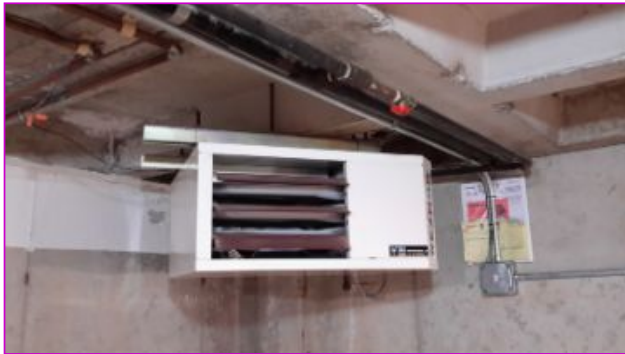
1. Garage General Condition

*lower garage*

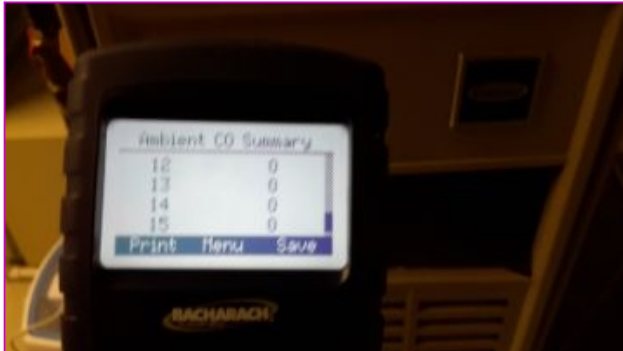
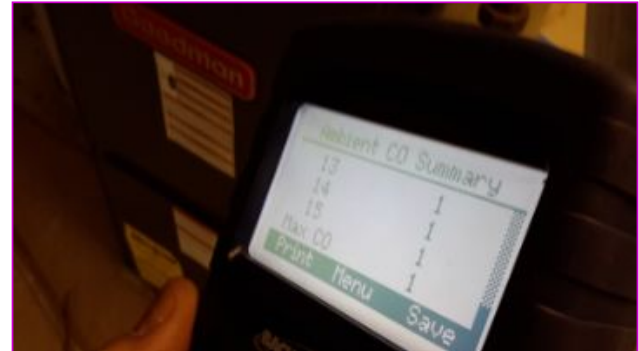
3. Furnace Operation

- Both furnaces responded adequately to the call for heat. Both furnaces also measured 0-1 parts per million of carbon monoxide in the plenum when tested today. They are both operating normally today.

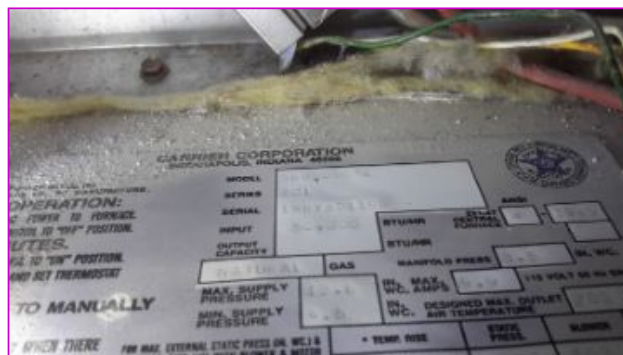
4. Furnace Manufacturer

• The furnaces were located in the unfinished portion of the basement. A Goodman furnace with AC was installed in 2008. An older furnace, possibly original, is used to heat the basement only. Not sure why the newer furnace was not installed to service both levels with zoned heating. Older furnace is a draft type exhaust, while the newer is a high efficiency that uses PVC pipe for its combustion air and it's exhaust.

older unit
